**CITY OF GRAND TERRACE**  
**Planning Commission/Site and Architectural**  
**Review Board**  
**AGENDA • June 5, 2025**

TITLE: Review and Consideration of Site and Architectural Review 24-03, Conditional Use Permit 24-02, Sign Program 24-01 and Environmental Review 24-01, A Request By The Applicant, Dutch Bros. LLC, To Establish A "Coffee Shop" Land Use And Construct A 984 Square-Foot Building, And Site Improvements For A New Dutch Bros Coffee Shop At 22115 Barton Road, Grand Terrace, CA 92313 (APN: 1167-213-10 and 11) In Barton Road Specific Plan, General Commercial (BRSP, GC) Zone, Planning Area 1.

# DUTCH BROS. COFFEE - CA5204, GRAND TERRACE, CA SITE - SURVEY OVERLAY PLAN

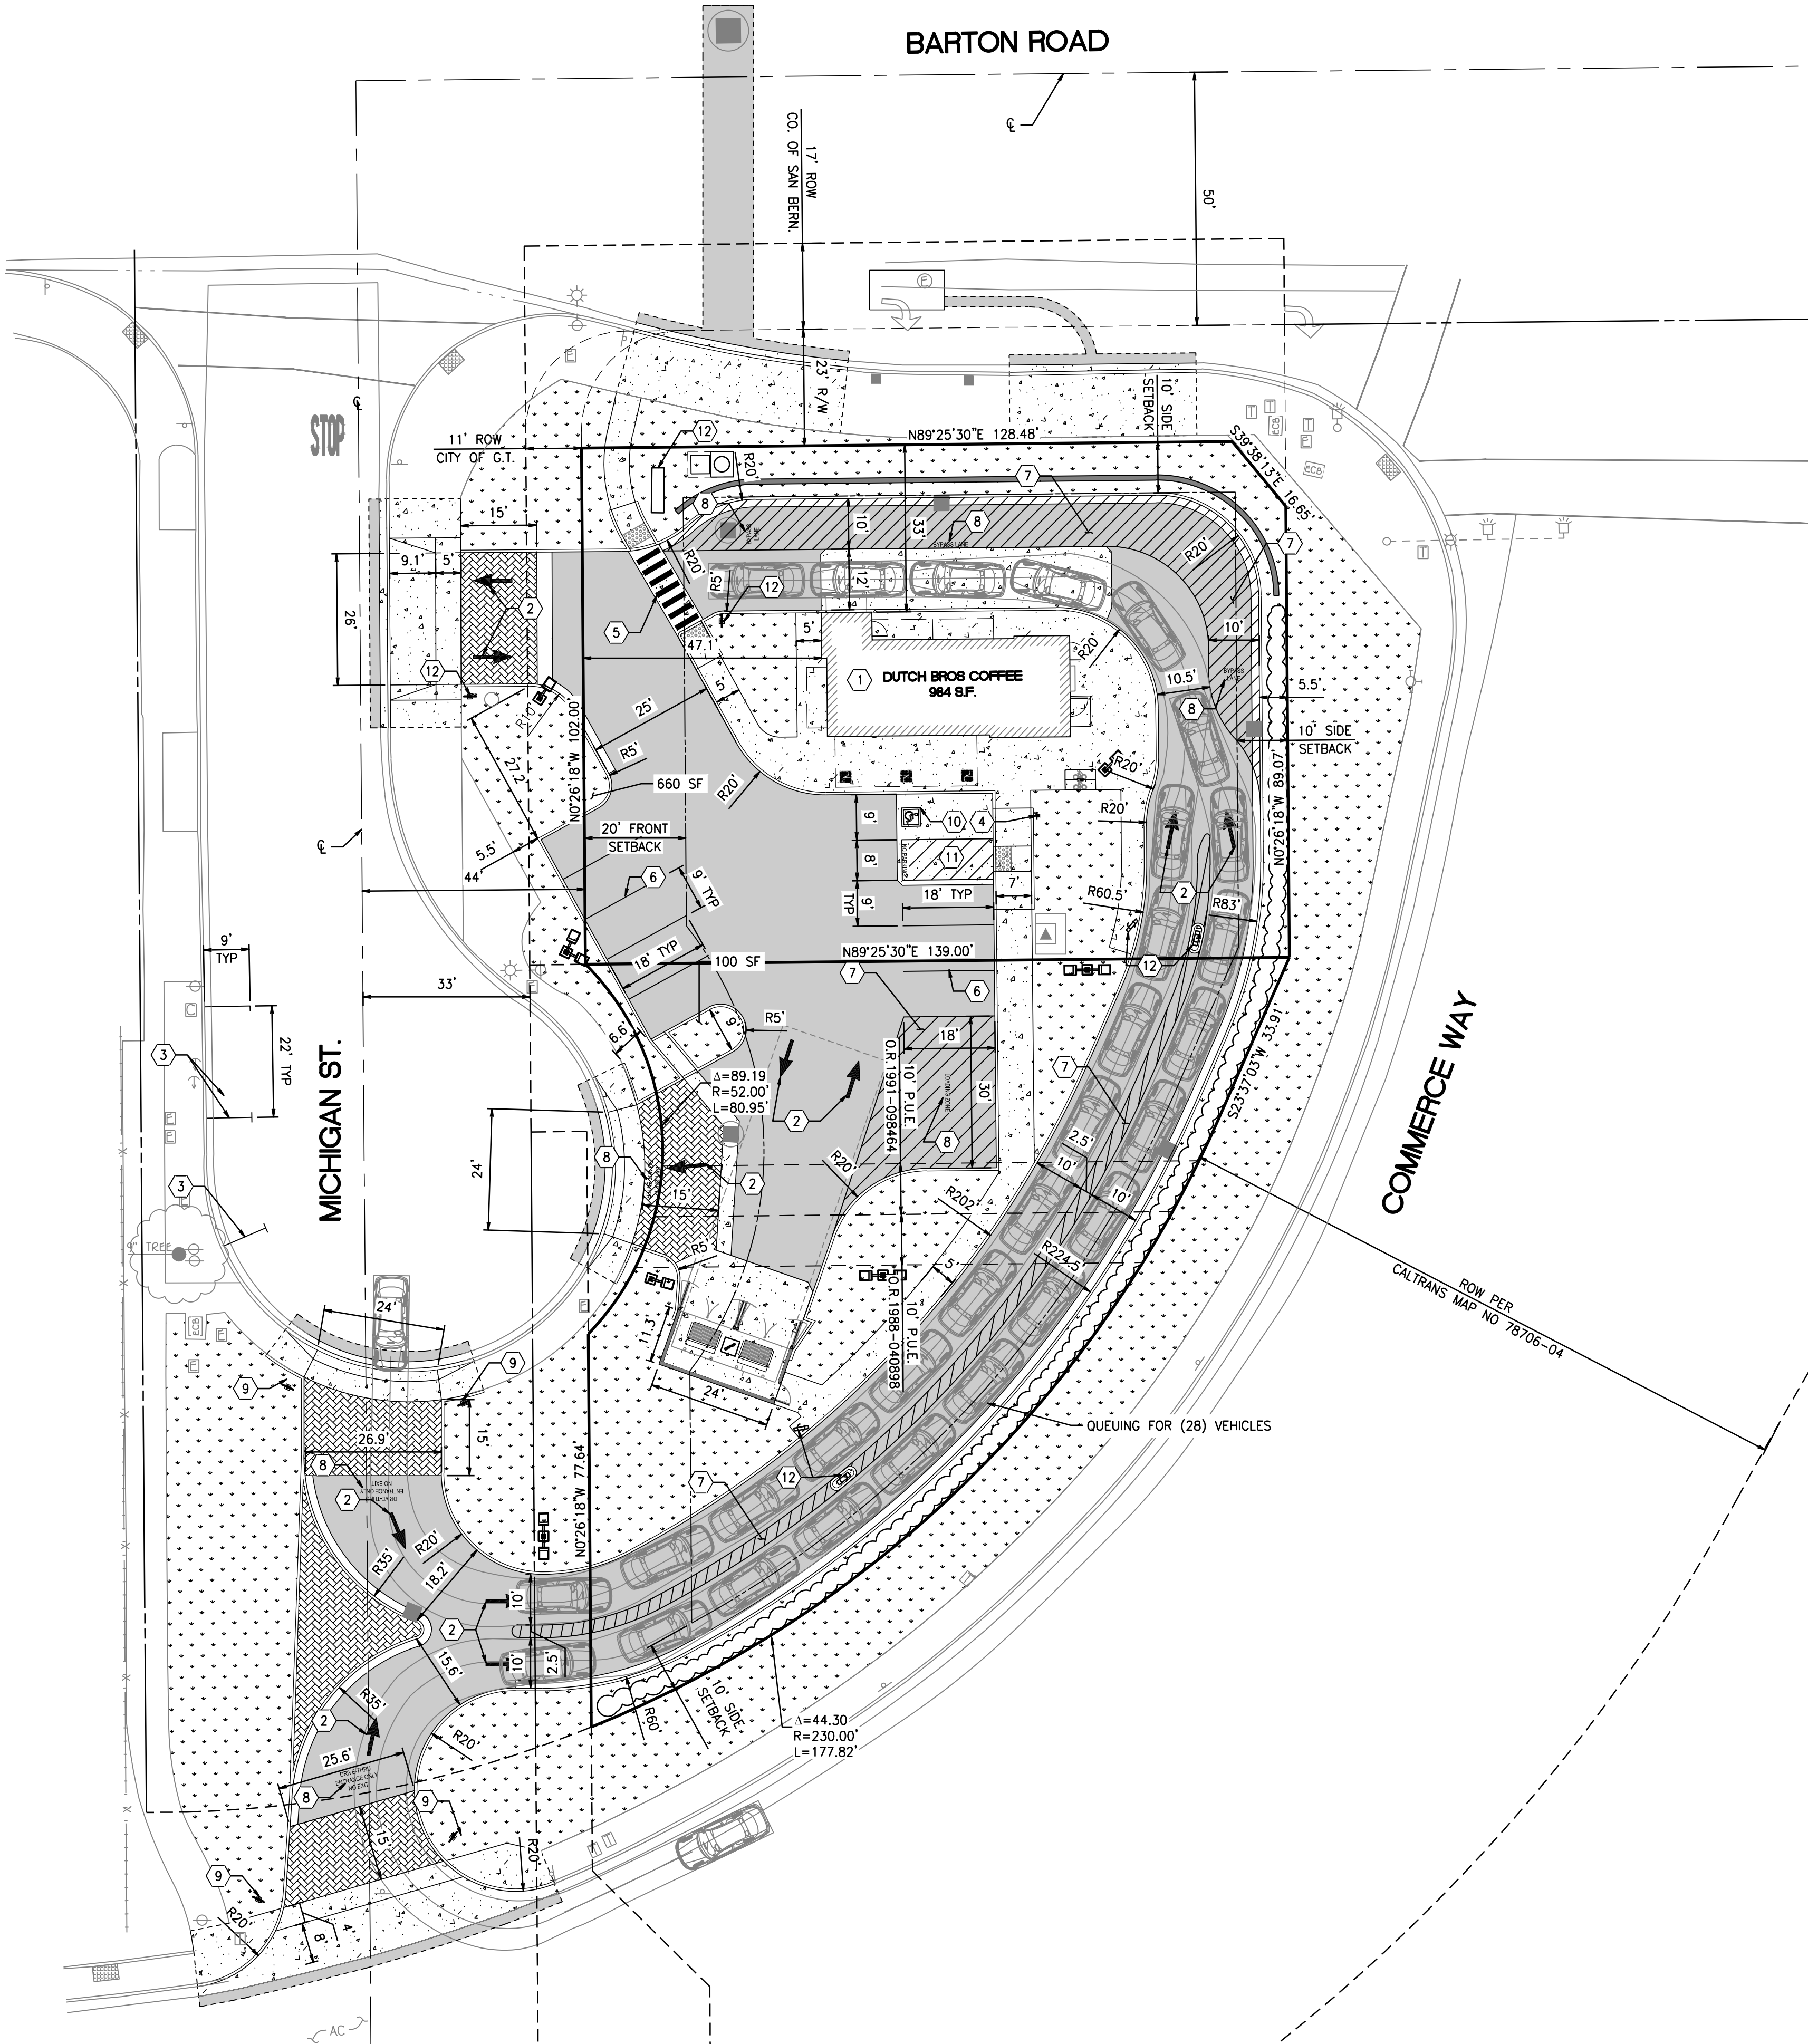
DUTCH BROS. COFFEE - CA5204, GRAND TERRACE, CA  
PRELIMINARY SIGNING AND STRIPING PLAN

- CONSTRUCTION NOTES:**
- PROPOSED DUTCH BROS. COFFEE, REFER TO ARCHITECTURAL PLANS FOR DETAILS.
  - PROPOSED DIRECTIONAL ARROW TO CITY OF GRAND TERRACE STANDARDS, TYPICAL.

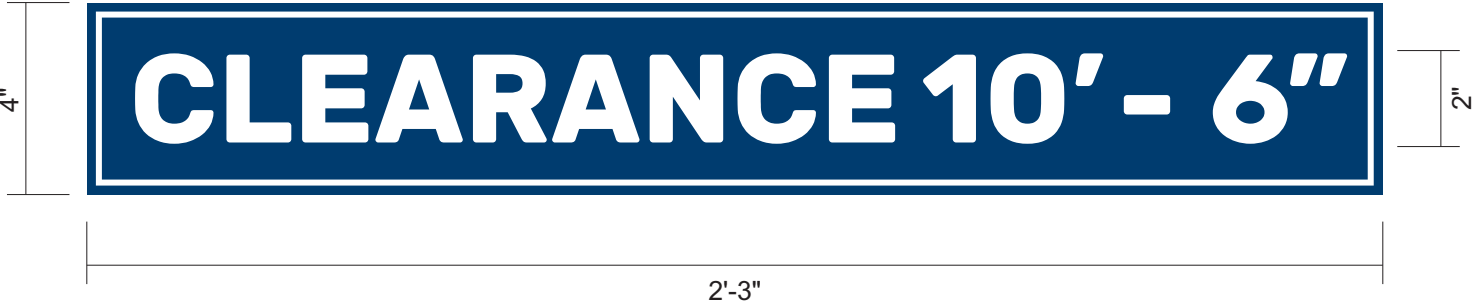
3MM ACM SIGN PANEL PAINTED DB CUSTOM DARK BLUE.  
WHITE REFLECTIVE VINYL COPY & BORDER (NUMBERS SHIPPED LOOSE & FIELD APPLIED).  
MOUNT DIRECTLY TO ALUMINUM AWNING DRIVE-THRU ENTRANCE SIDE  
WITH EXTERIOR GRADE 3M VHB TAPE.

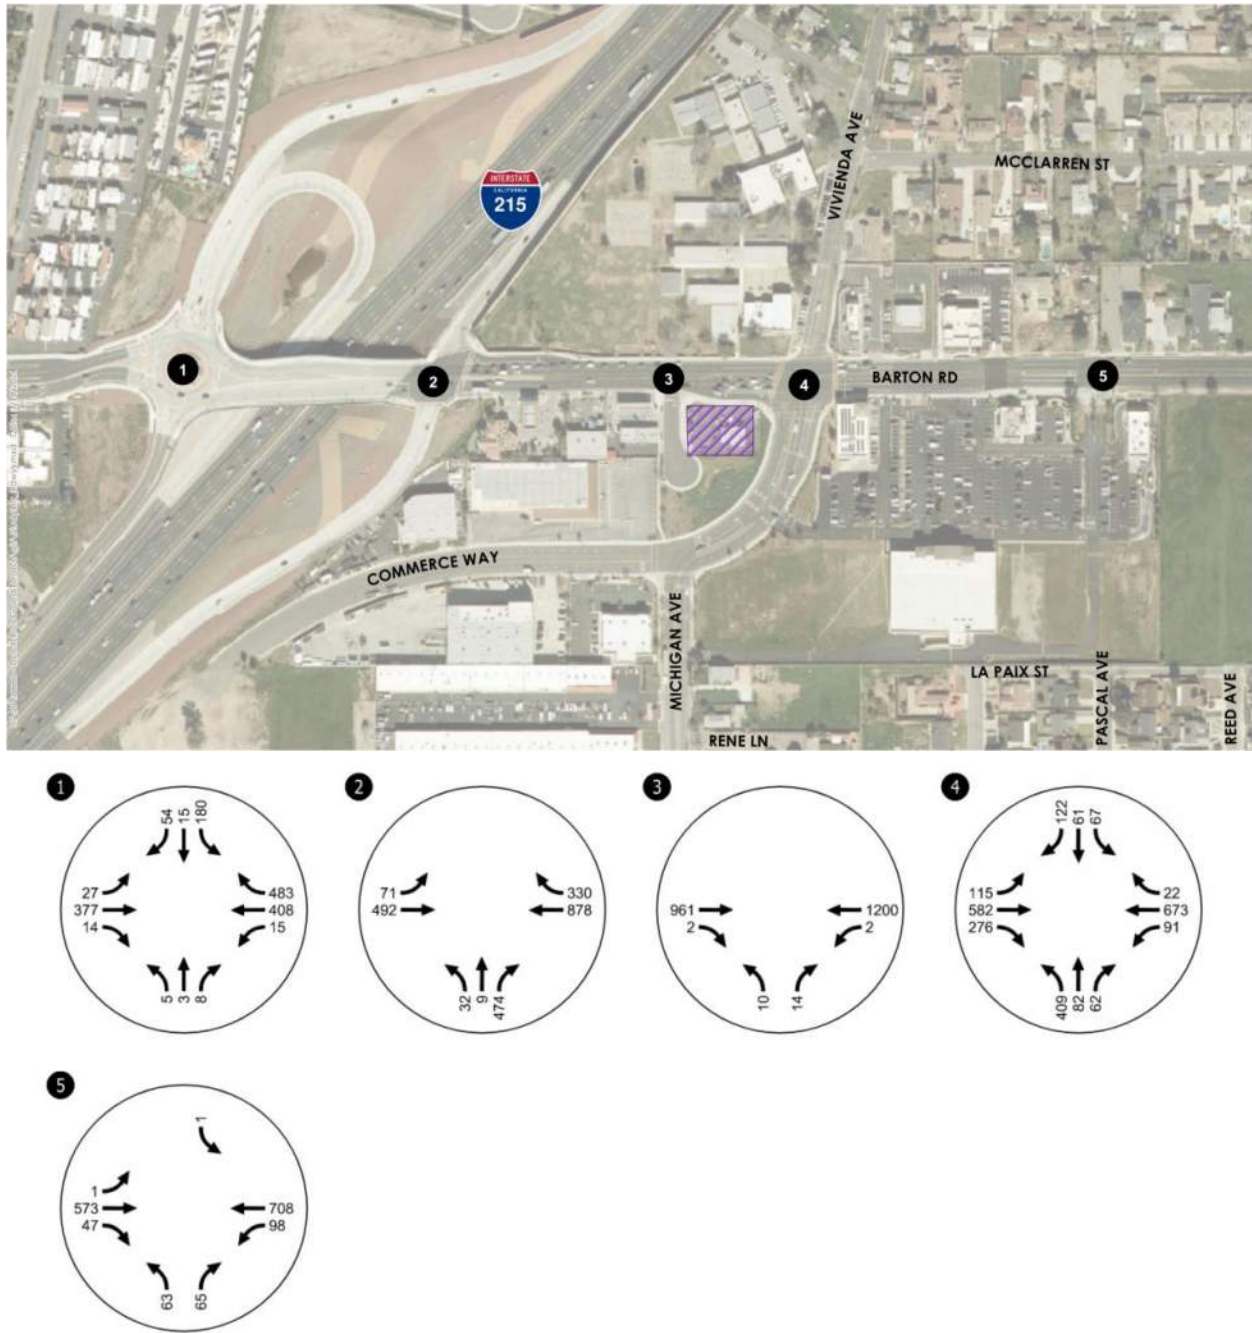
Figure 7: AM Peak Hour Volumes Under Existing Conditions

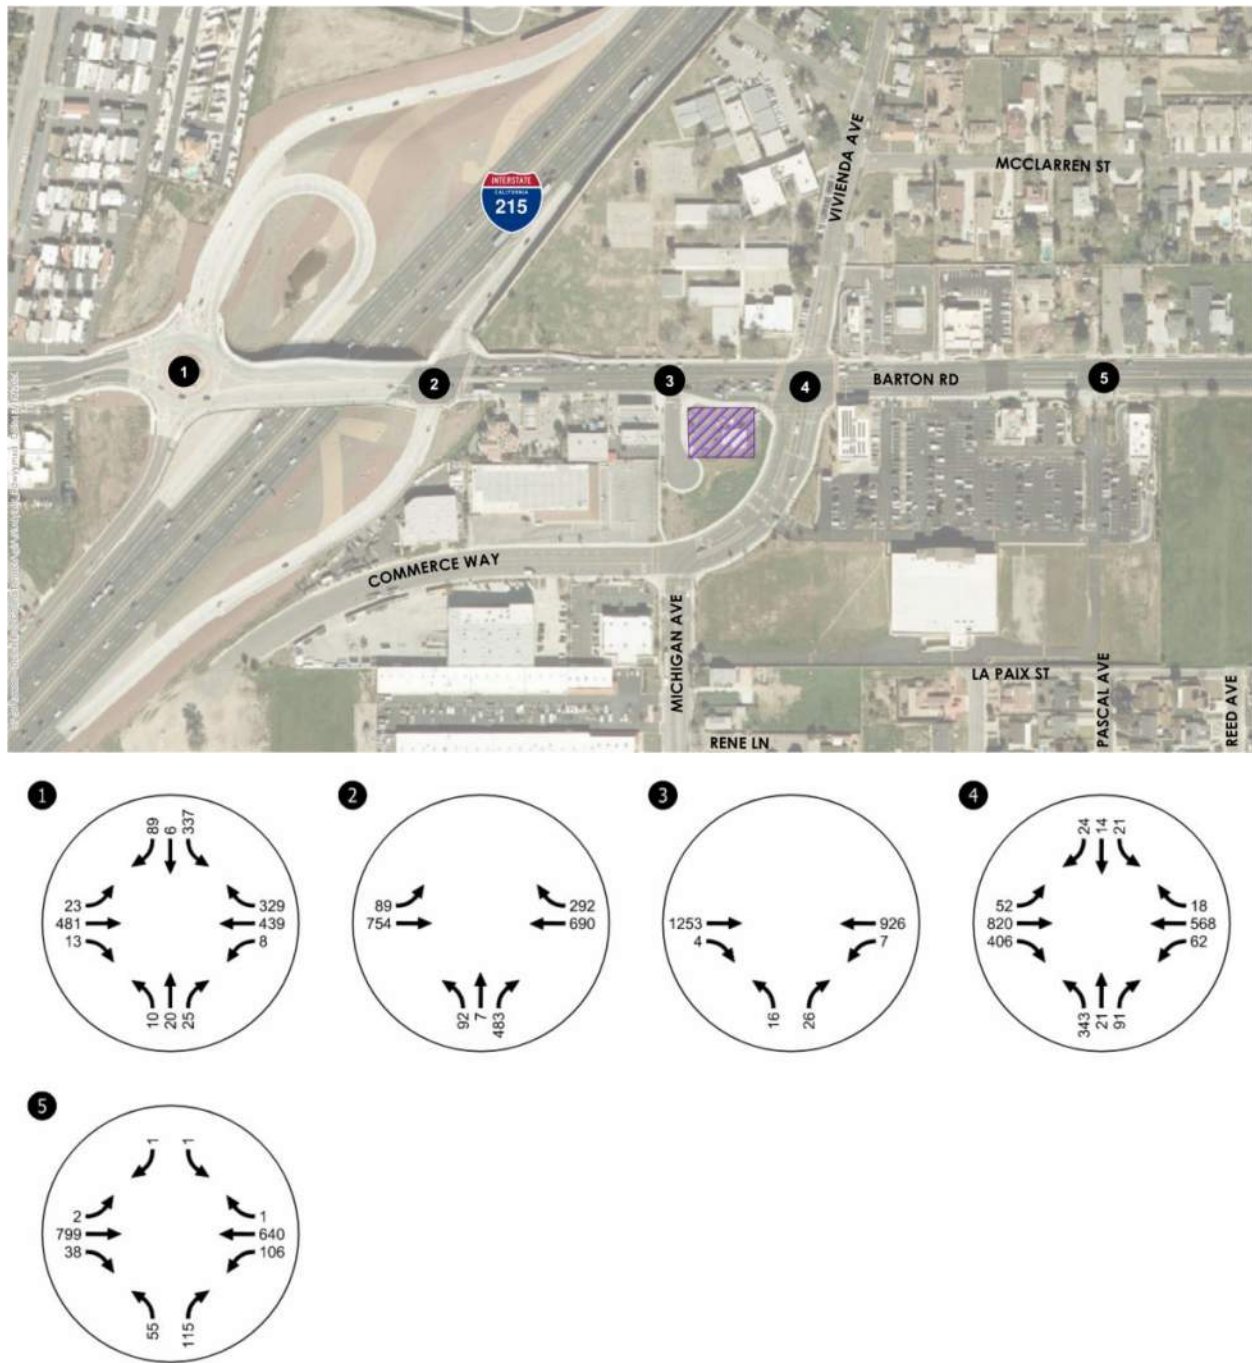
Figure 8: PM Peak Hour Volumes Under Existing Conditions

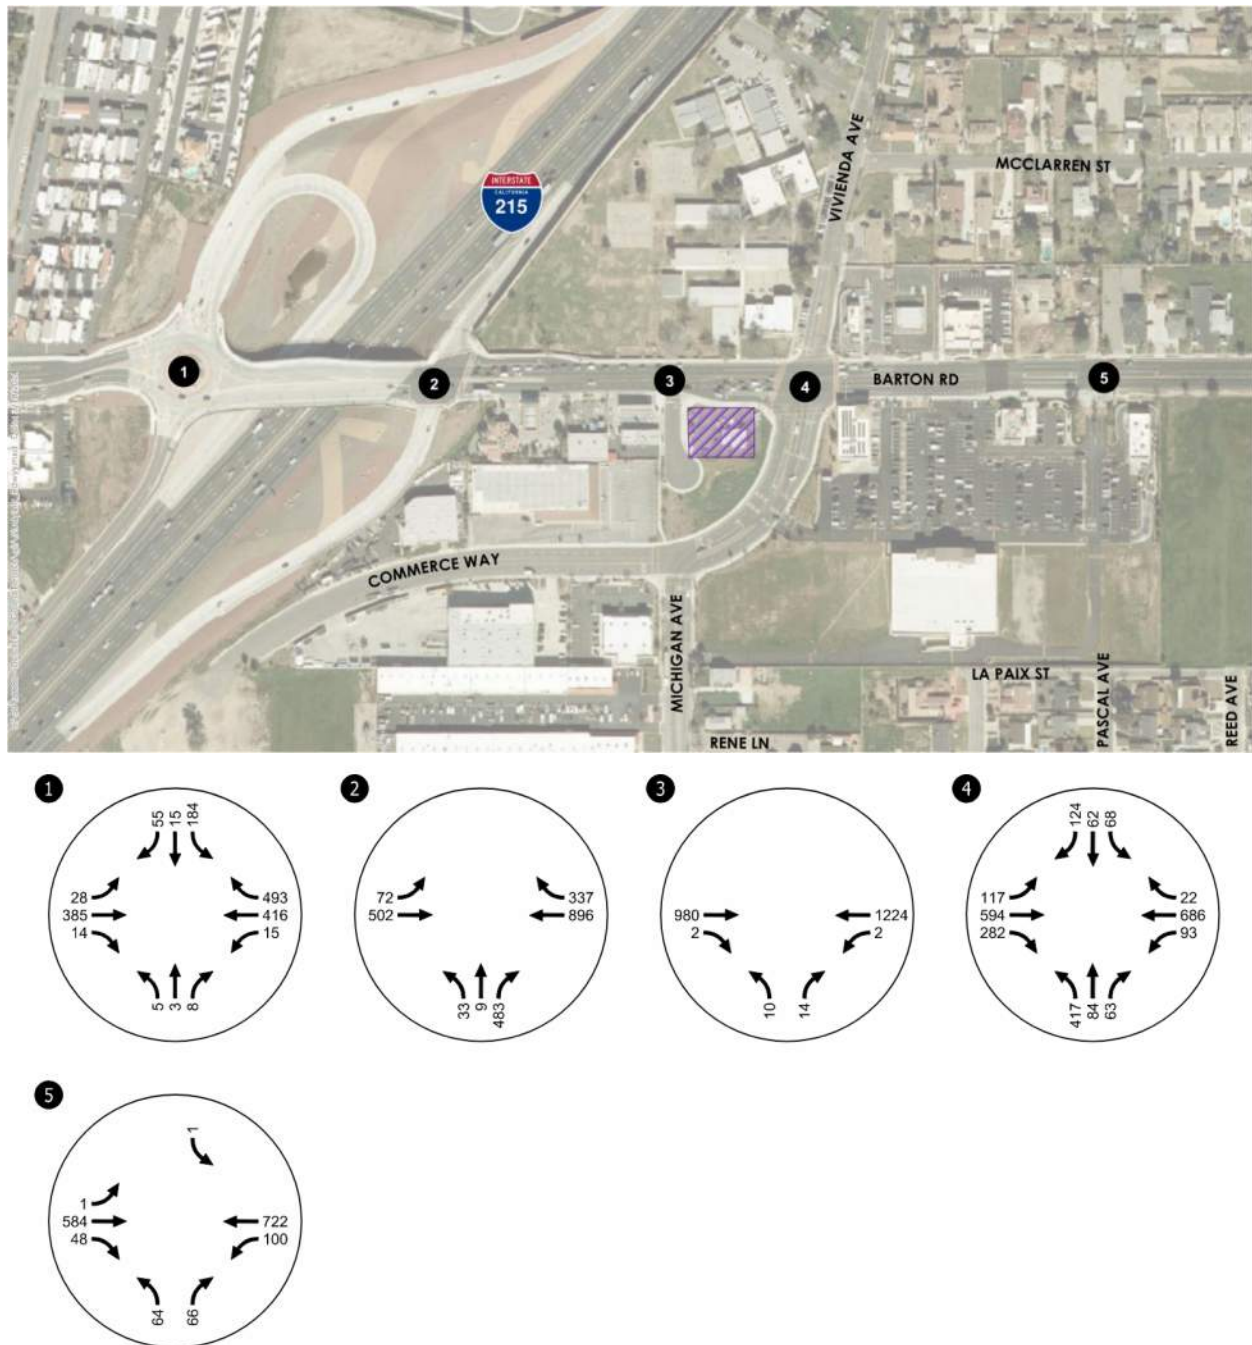
Figure 9: AM Peak Hour Volumes Under Existing Plus Ambient Growth Conditions

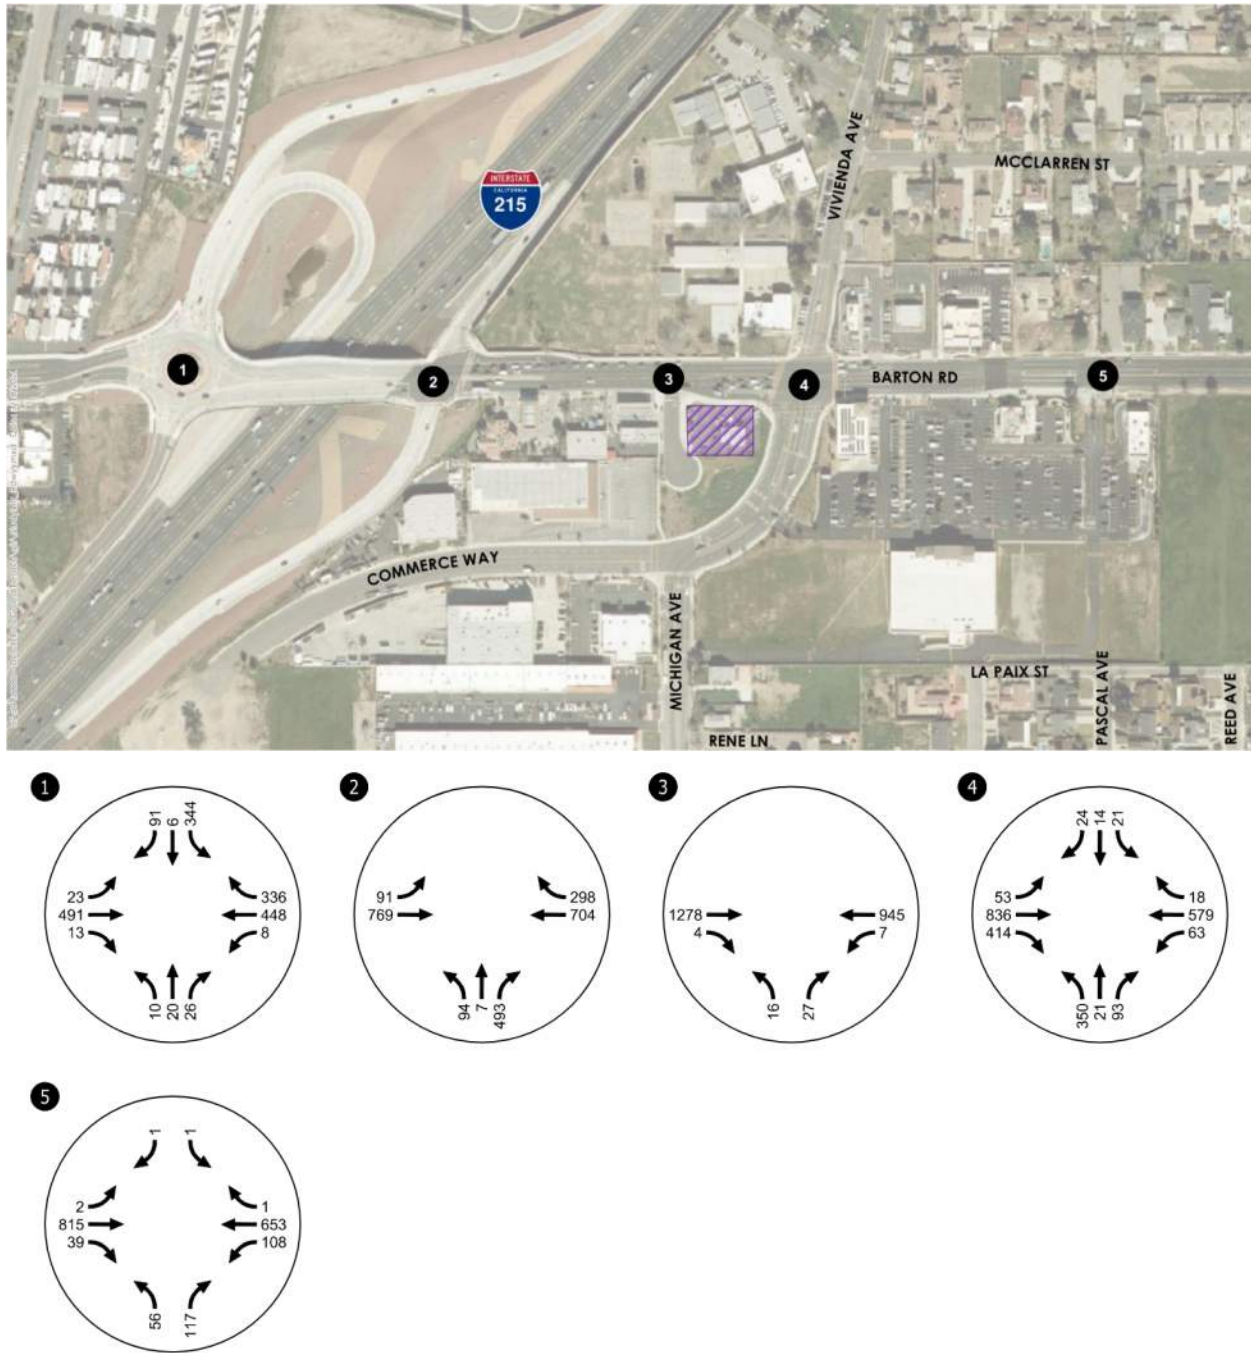
Figure 10: AM Peak Hour Volumes Under Existing Plus Ambient Growth Conditions

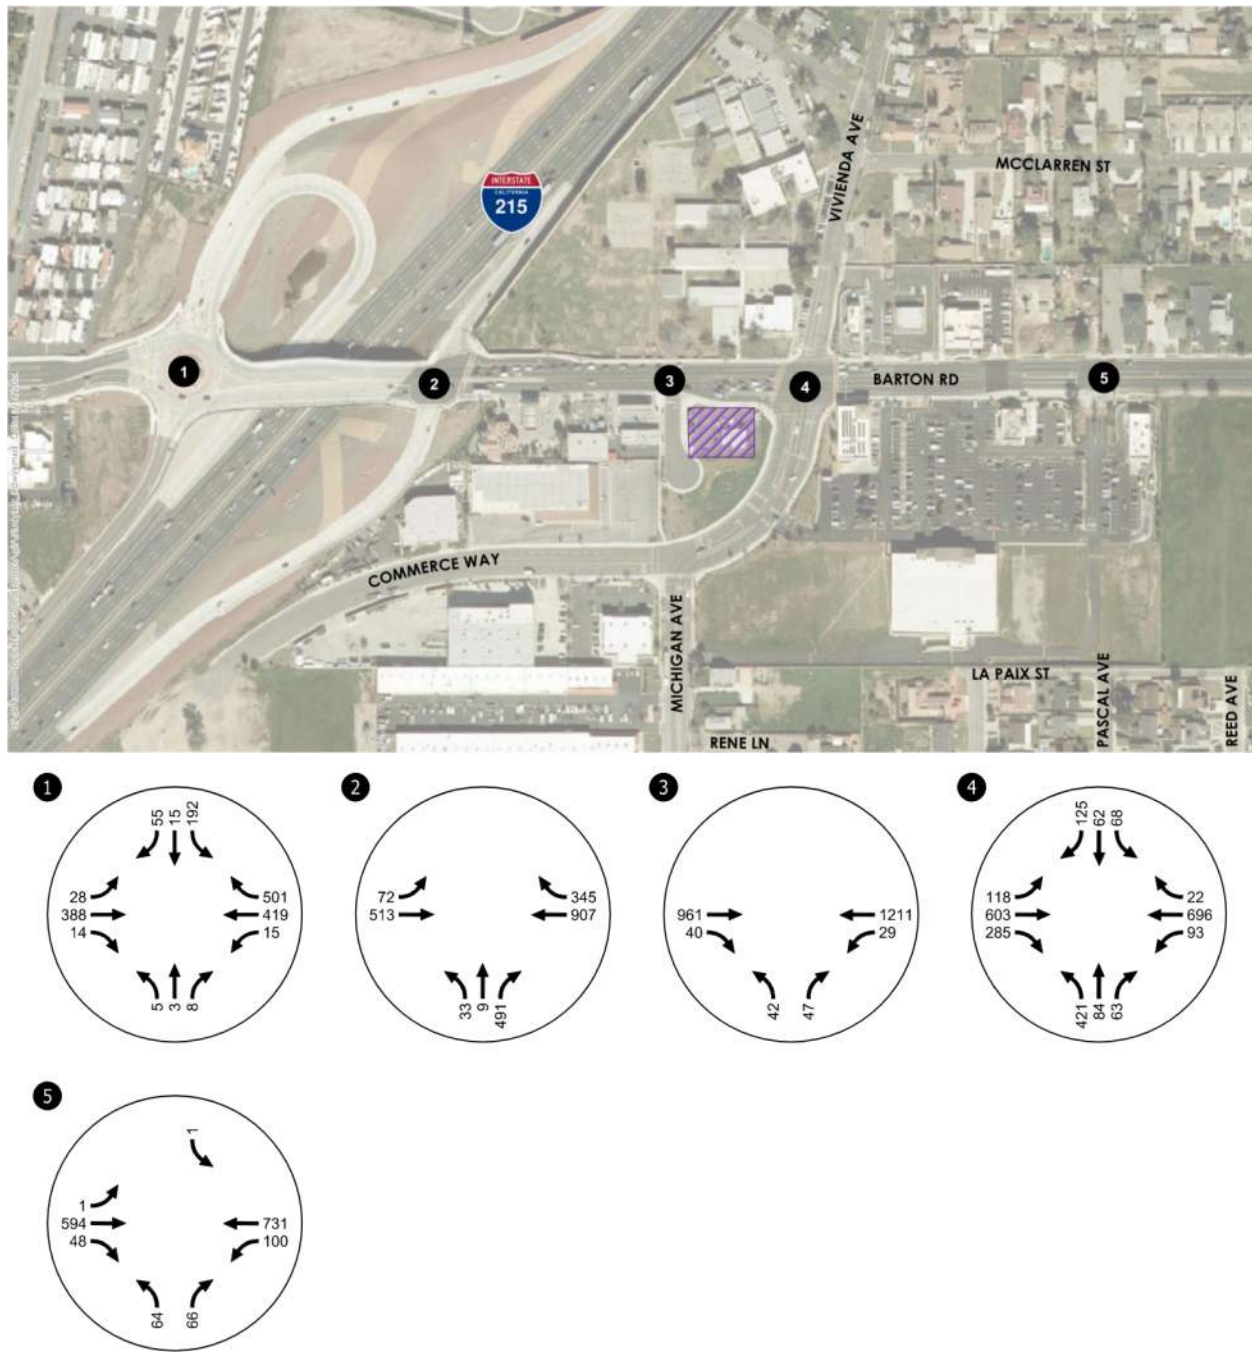
Figure 11: AM Peak Hour Volumes Under Existing Plus Ambient Growth Plus Project Conditions

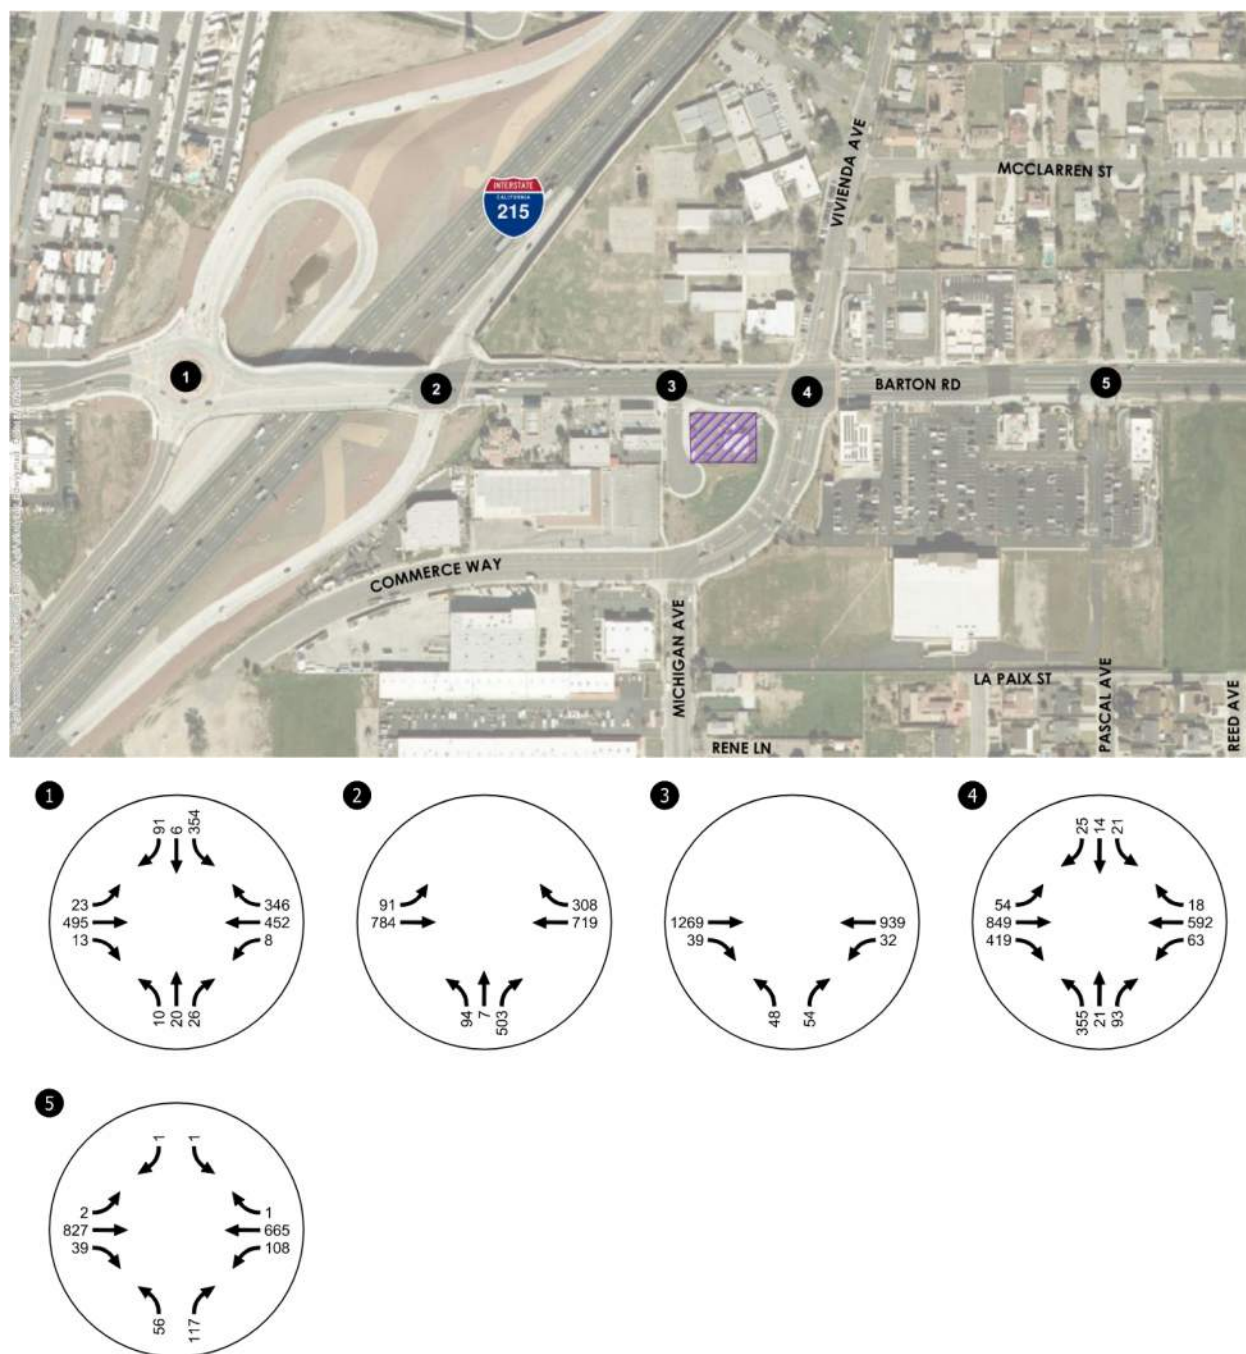
Figure 12: PM Peak Hour Volumes Under Existing Plus Ambient Growth Plus Project Conditions

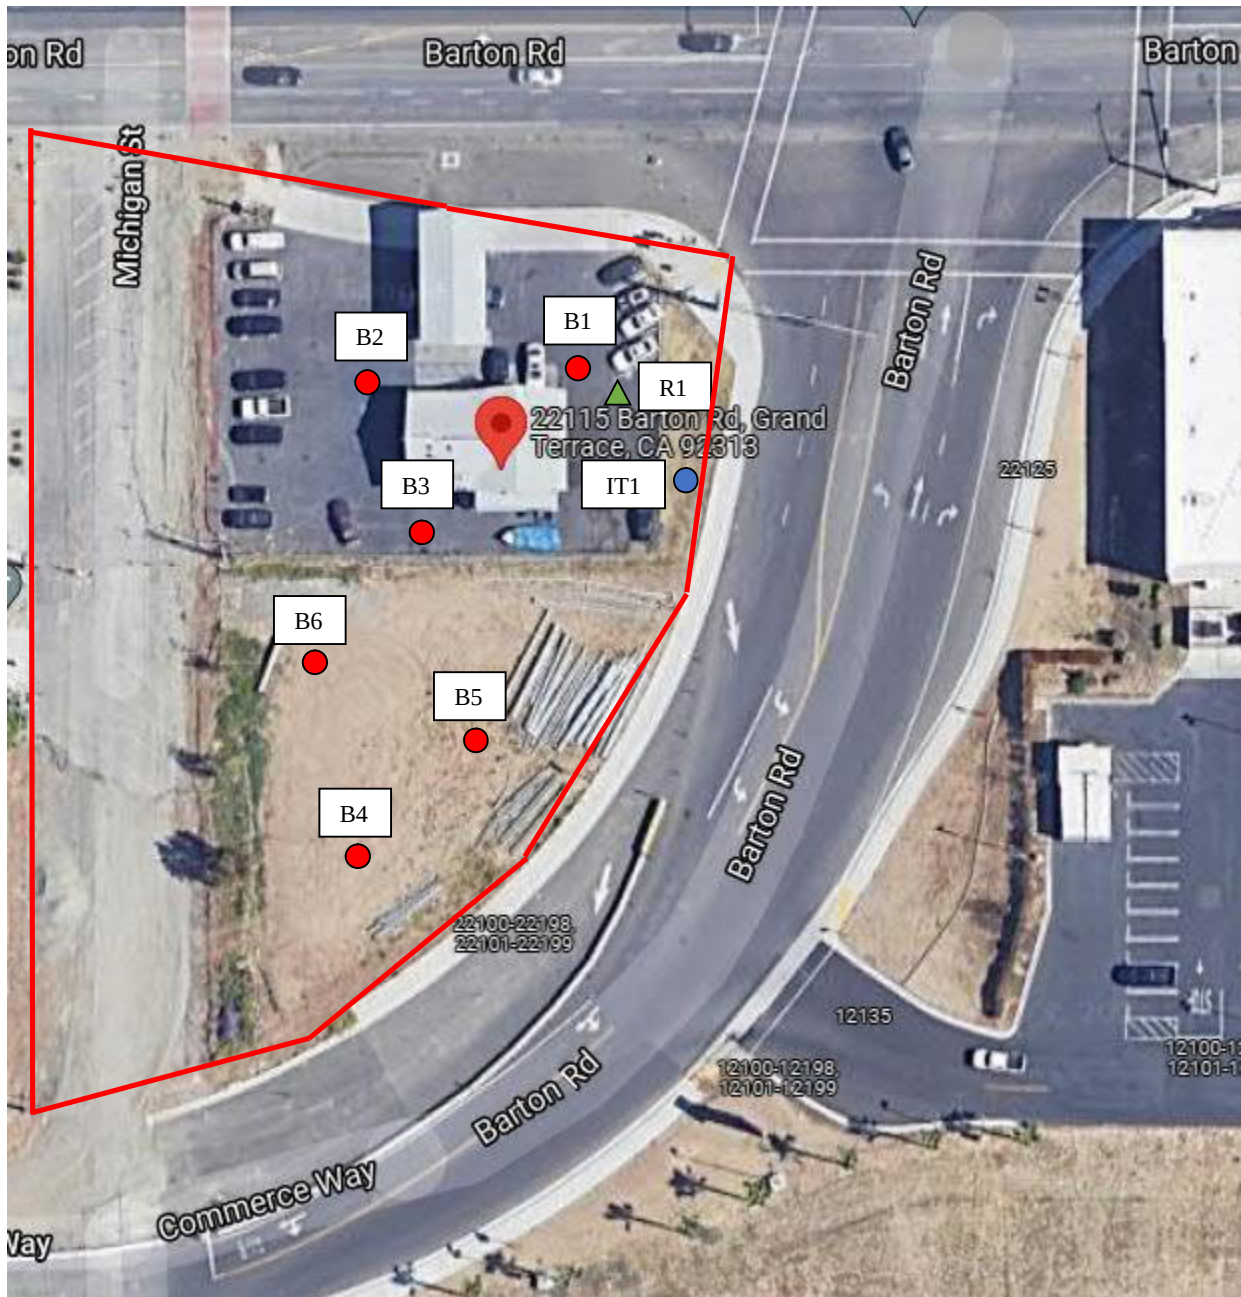
- APPROXIMATE BORING LOCATION
- APPROXIMATE INFILTRATION TEST LOCATION
- ▲ APPROXIMATE R-VALUE LOCATION

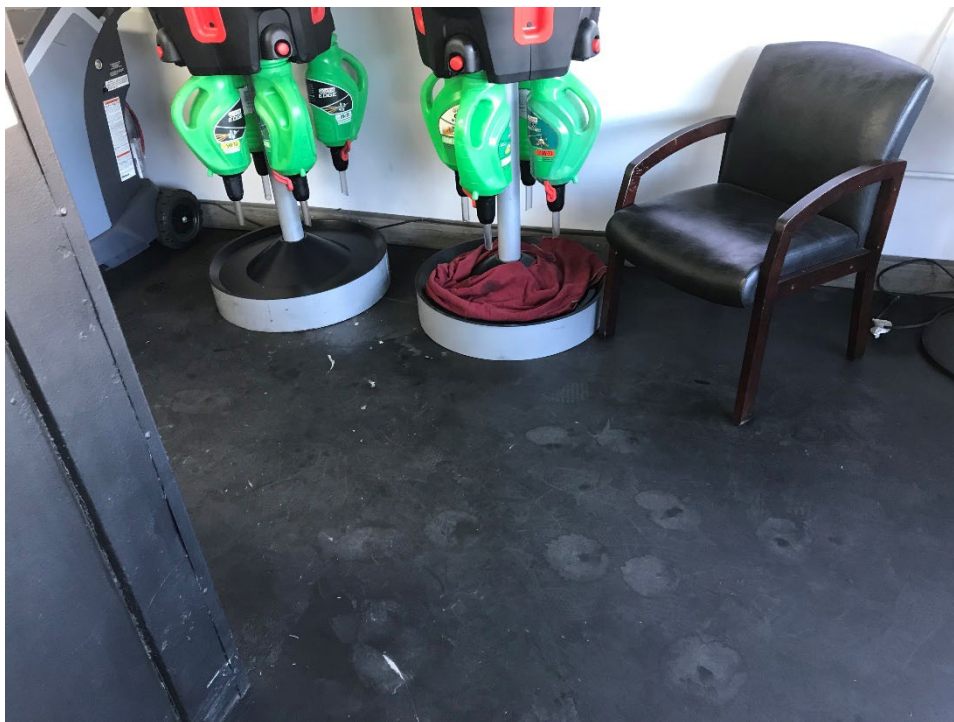
**Photograph 10.** De minimis staining in the office area of the Subject Property building.

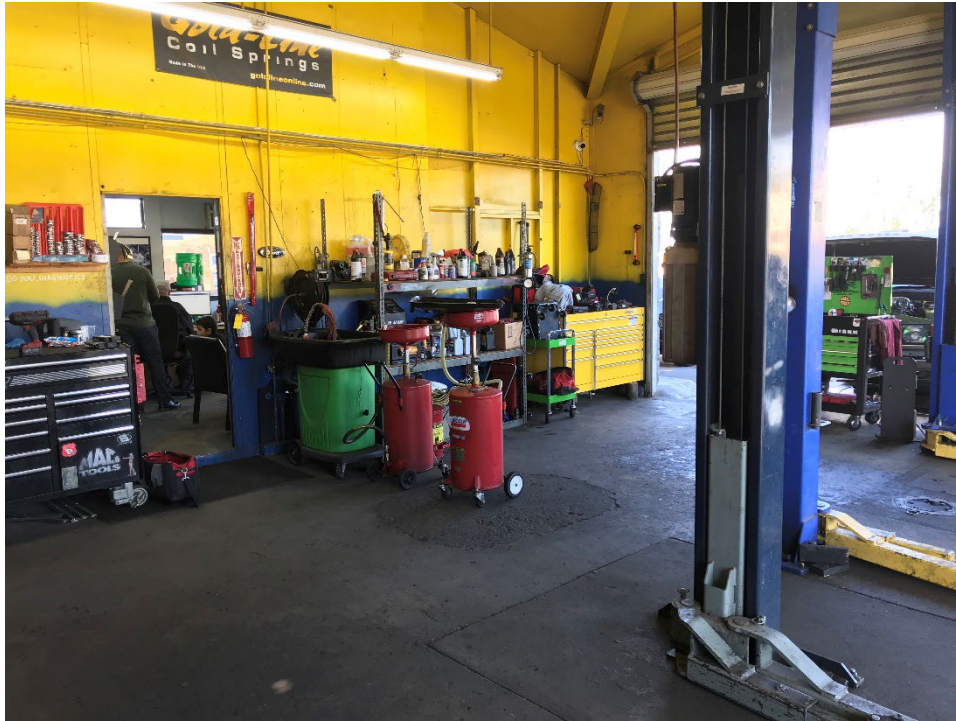
**Photograph 11.** General auto repair shop in the eastern portion of the Subject Property building.

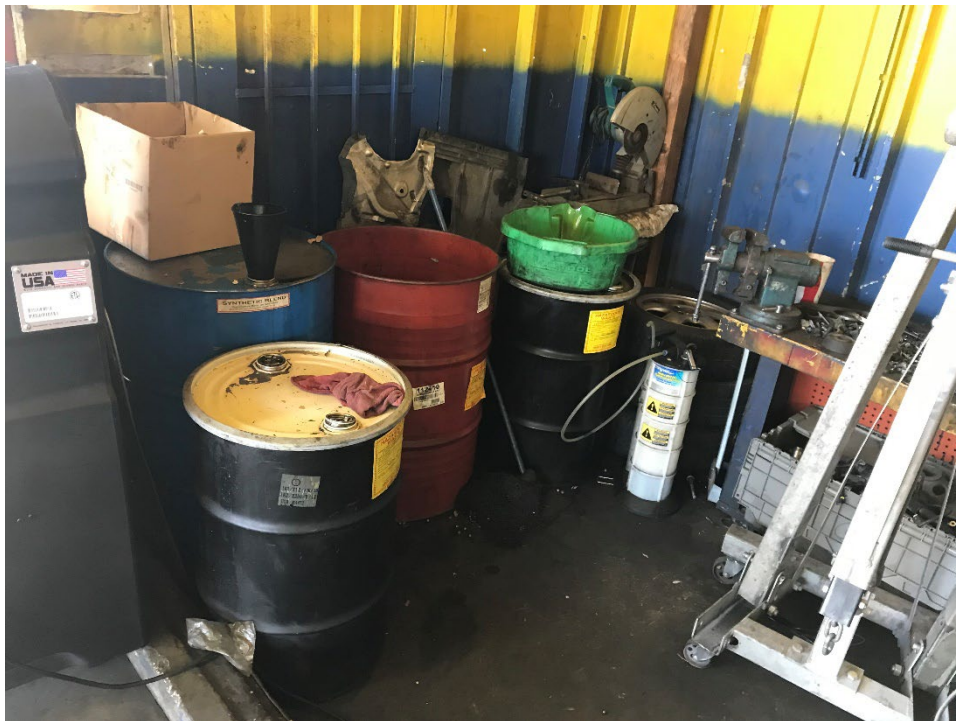
**Photograph 12.** Hazardous waste storage area in the southeastern portion of the auto body shop of the Subject Property building.

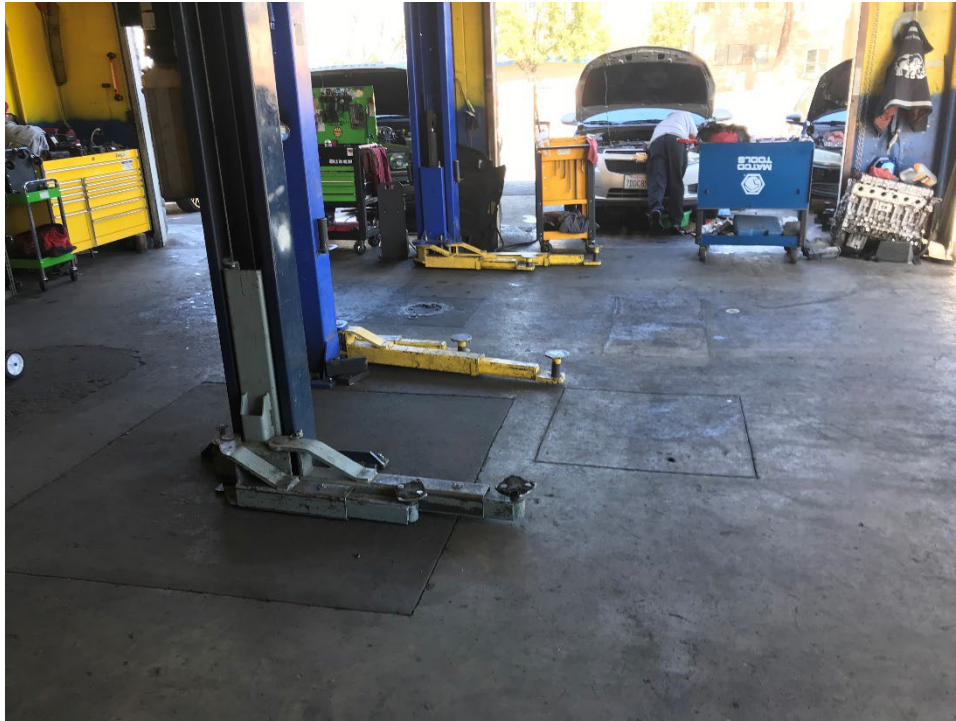
**Photograph 13.** Aboveground hydraulic lifts in the auto repair shop of the Subject Property building.

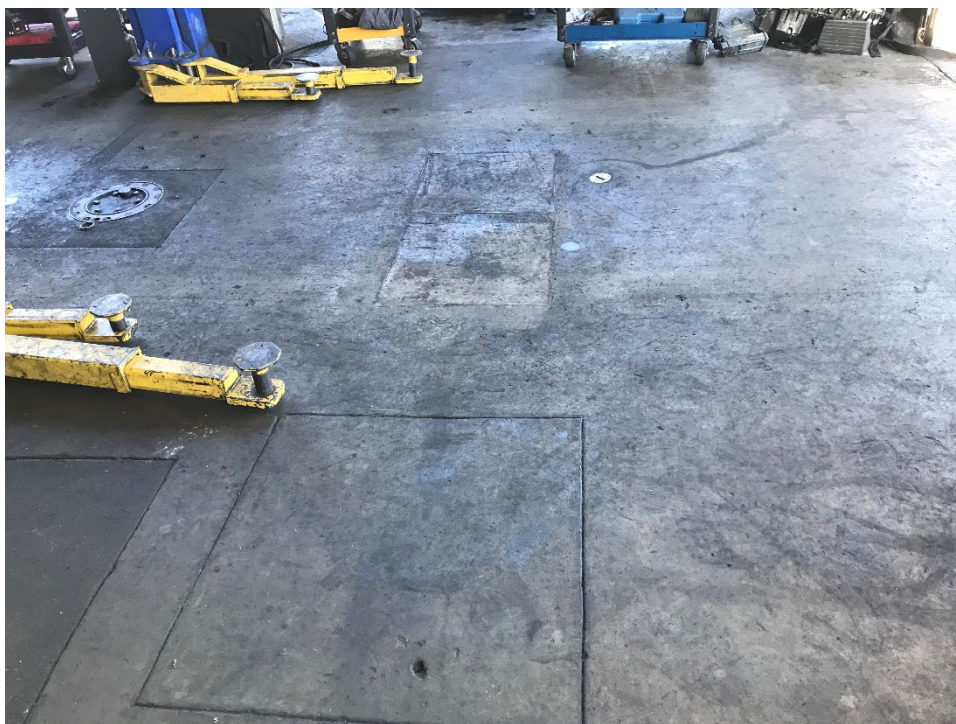
**Photograph 14.** Patched area inside the auto body shop; possible former clarifier.

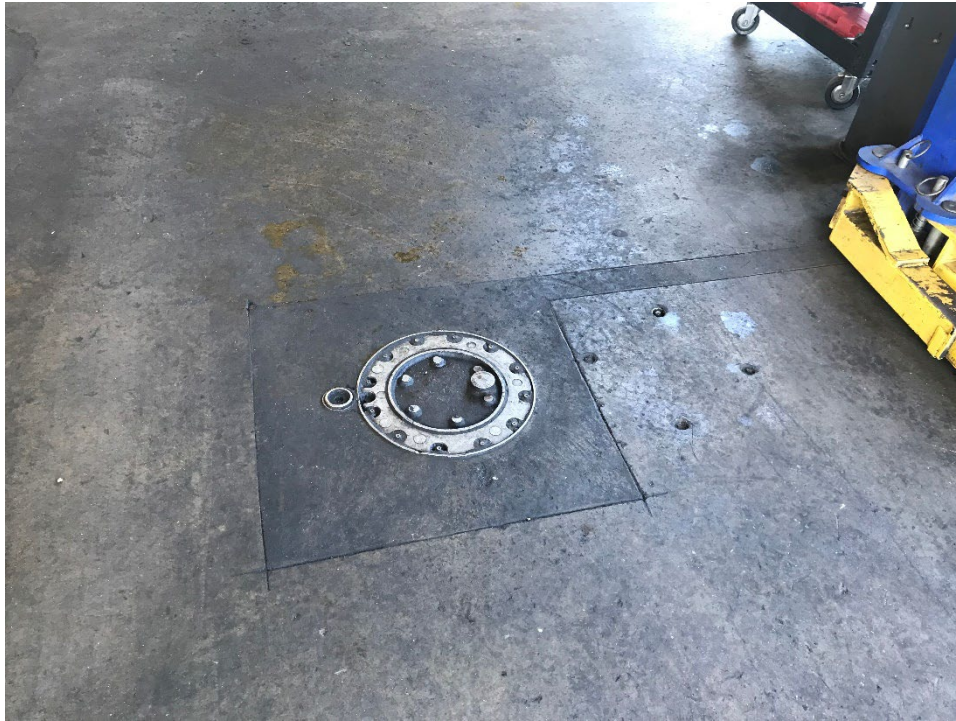
**Photograph 15.** Former in-ground piston lift in the auto repair shop of the Subject Property building.

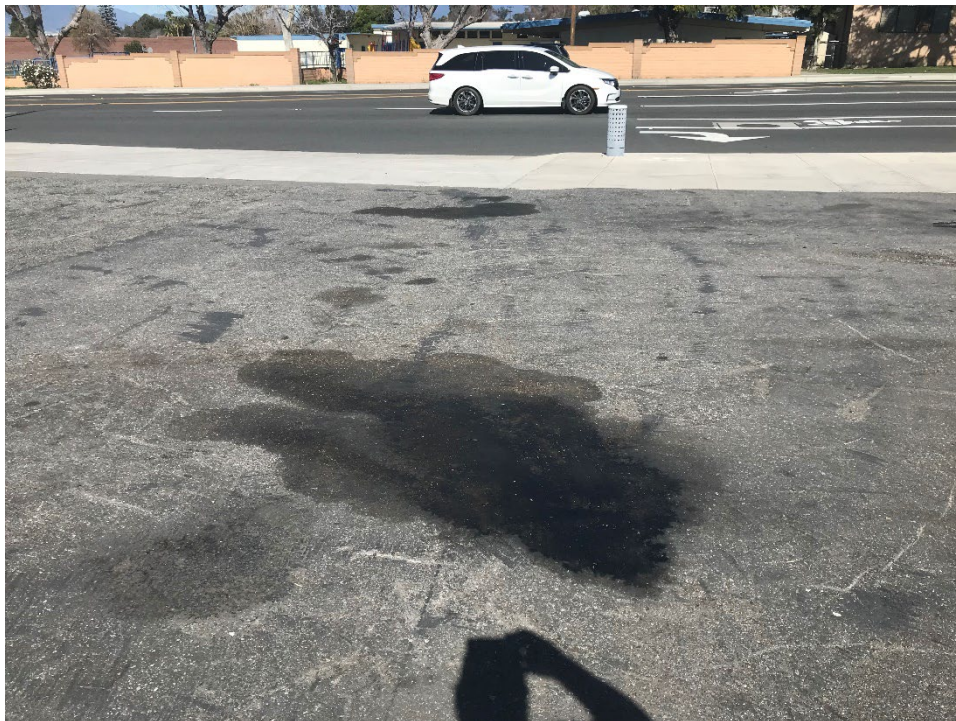
**Photograph 20.** Staining in the parking area of the Subject Property.

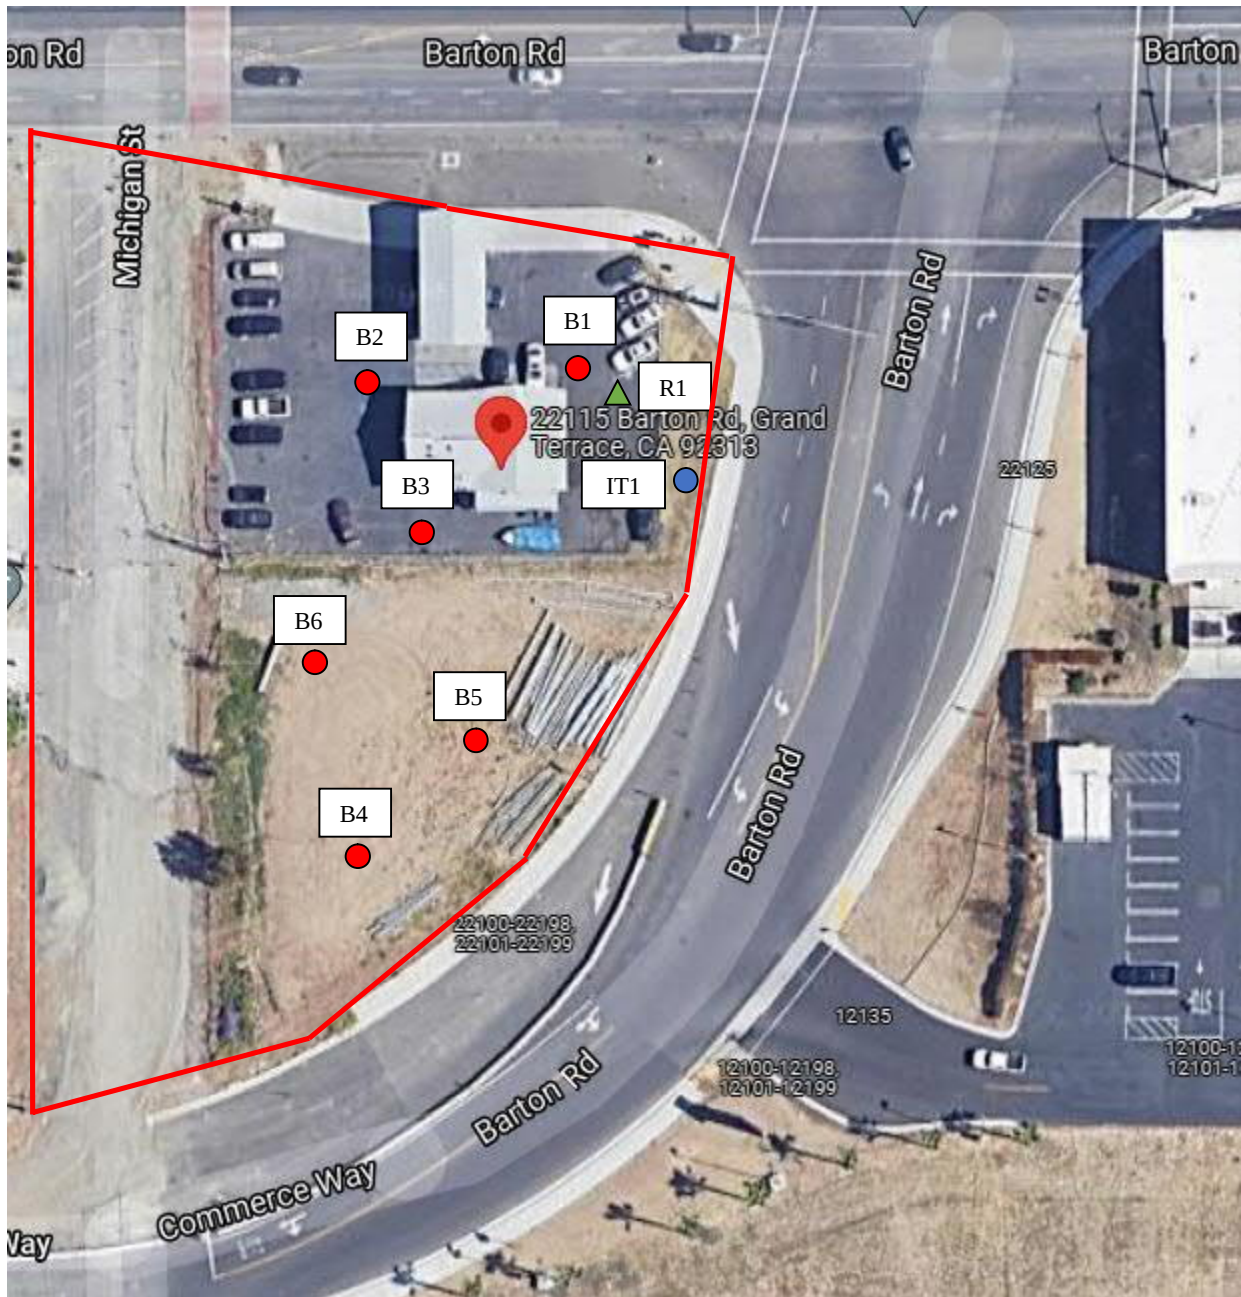
- APPROXIMATE BORING LOCATION
- APPROXIMATE INFILTRATION TEST LOCATION
- ▲ APPROXIMATE R-VALUE LOCATION
