**CITY OF GRAND TERRACE**  
**Planning Commission/Site and Architectural**  
**Review Board**  
**AGENDA • June 5, 2025**

TITLE: Review and Consideration of Site and Architectural Review 24-03, Conditional Use Permit 24-02, Sign Program 24-01 and Environmental Review 24-01, A Request By The Applicant, Dutch Bros. LLC, To Establish A "Coffee Shop" Land Use And Construct A 984 Square-Foot Building, And Site Improvements For A New Dutch Bros Coffee Shop At 22115 Barton Road, Grand Terrace, CA 92313 (APN: 1167-213-10 and 11) In Barton Road Specific Plan, General Commercial (BRSP, GC) Zone, Planning Area 1.

# DUTCH BROS. COFFEE - CA5204, GRAND TERRACE, CA SITE - SURVEY OVERLAY PLAN

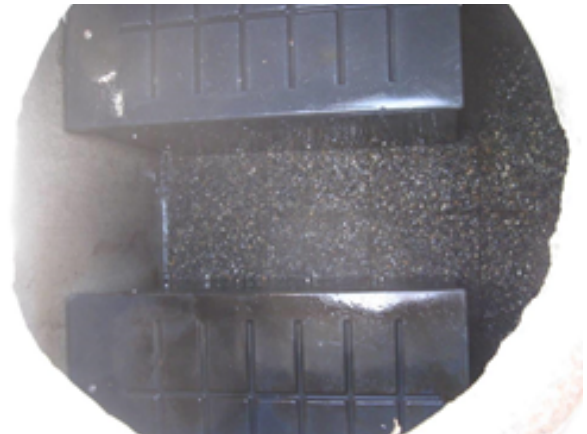
1. Remove access cover over pre-treatment chamber and position vacuum truck accordingly.
2. With a pressure washer, spray down pollutants accumulated on walls and pre-filter cartridges.
3. Vacuum out pre-treatment chamber and remove all accumulated pollutants including trash, debris, and sediments. Be sure to vacuum the floor until the pervious pavers are visible and clean.
4. If pre-filter cartridges require media replacement, continue to step 5. If not, replace access cover and move to step 11.
