**CITY OF GRAND TERRACE**  
**Planning Commission/Site and Architectural**  
**Review Board**  
**AMENDED AGENDA • June 19, 2025**

- 2) Review and Consideration of Site and Architectural Review 24-03, Conditional Use Permit 24-02, Sign Program 24-01 and Environmental Review 24-01, A Request By The Applicant, Dutch Bros. LLC, To Establish A “Coffee Shop” Land Use And Construct A 984 Square-Foot Building, And Site Improvements For A New Dutch Bros Coffee Shop At 22115 Barton Road, Grand Terrace, CA 92313 (APN: 1167-213-10 and 11) In Barton Road Specific Plan, General Commercial (BRSP, GC) Zone, Planning Area 1. An IS/MND and Mitigation Monitoring and Reporting Program (MMRP) has Been Prepared for the Project Consistent With the Requirements of the California Environmental Quality Act (CEQA) Pursuant To Section §15074 of the CEQA Guidelines

TITLE: Review and Consideration of Site and Architectural Review 24-03, Conditional Use Permit 24-02, Sign Program 24-01 and Environmental Review 24-01, A Request By The Applicant, Dutch Bros. LLC, To Establish A "Coffee Shop" Land Use And Construct A 984 Square-Foot Building, And Site Improvements For A New Dutch Bros Coffee Shop At 22115 Barton

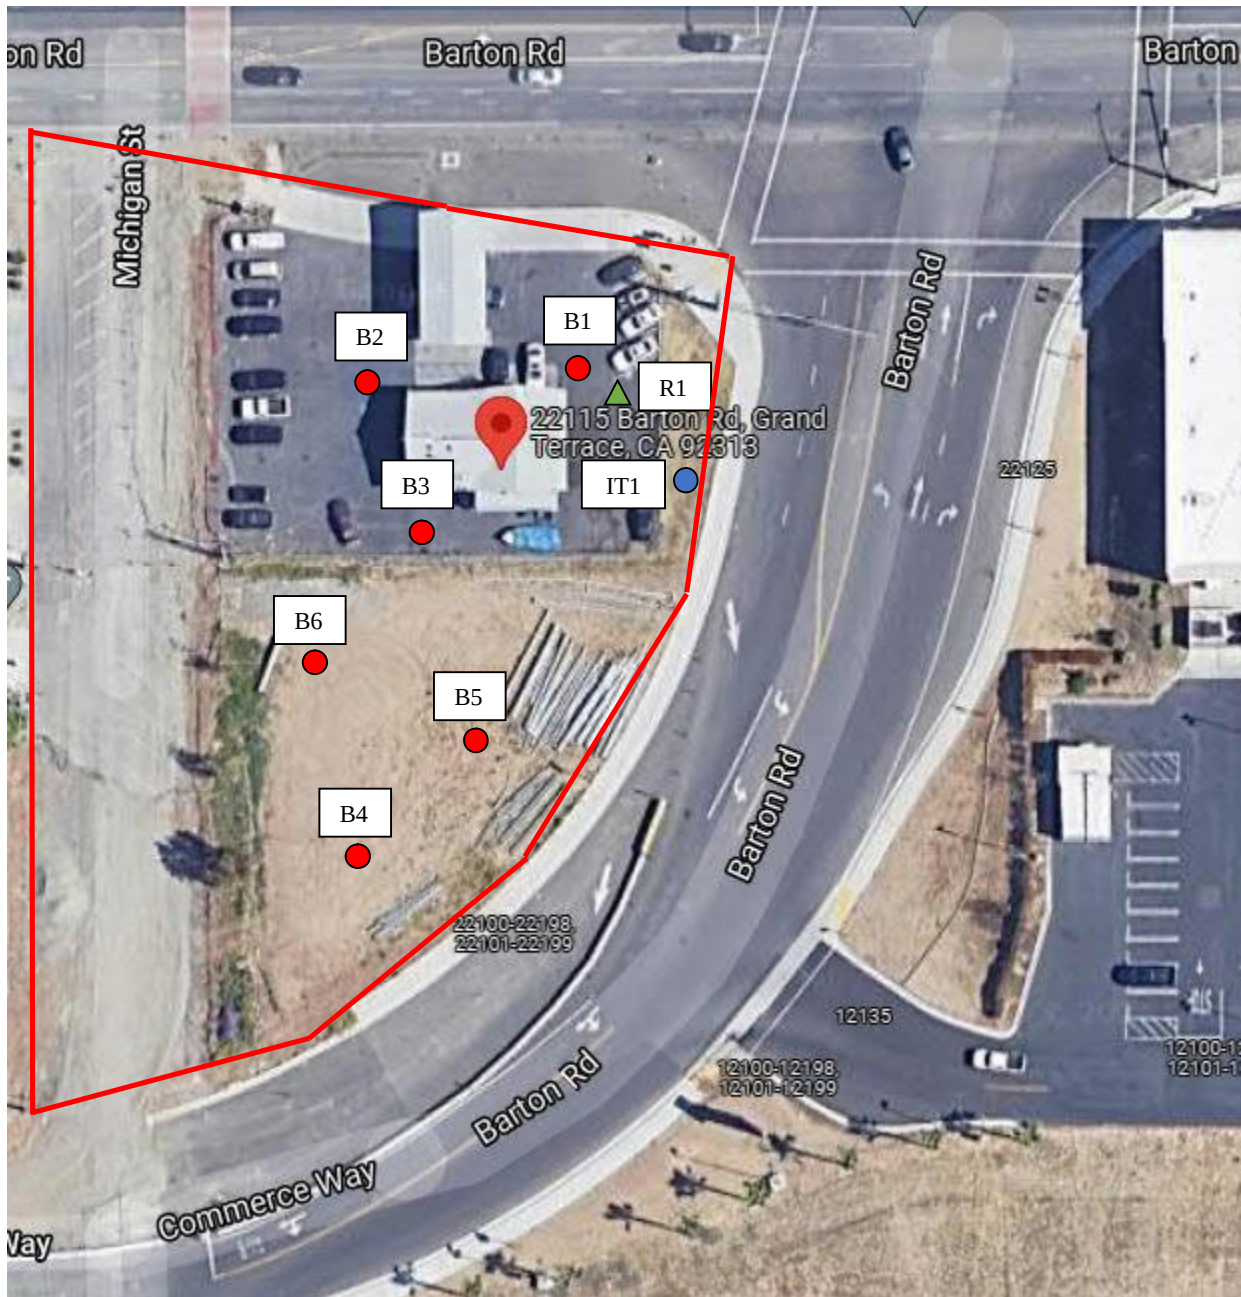
- APPROXIMATE BORING LOCATION
- APPROXIMATE INFILTRATION TEST LOCATION
- ▲ APPROXIMATE R-VALUE LOCATION

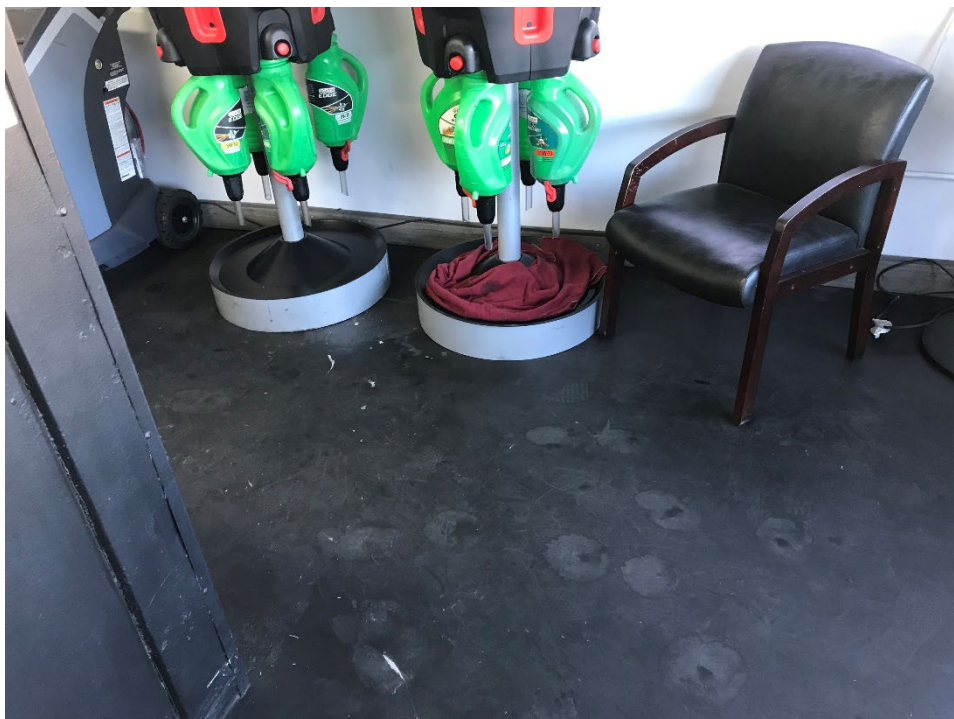
**Photograph 9.** New oil storage and dispenser in the office area of the Subject Property building.

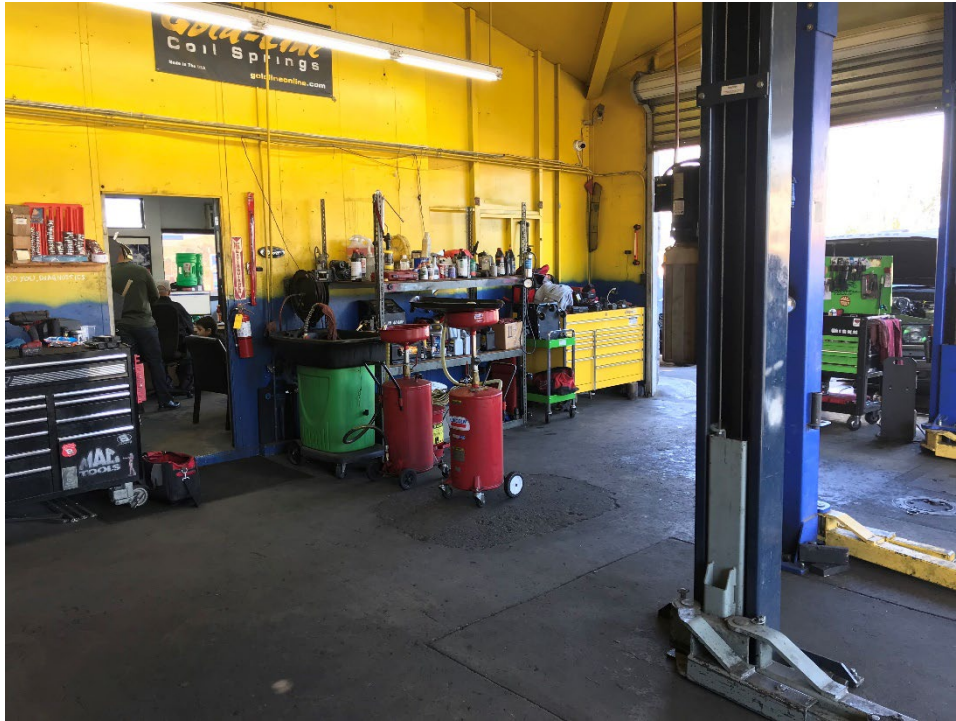
**Photograph 11.** General auto repair shop in the eastern portion of the Subject Property building.

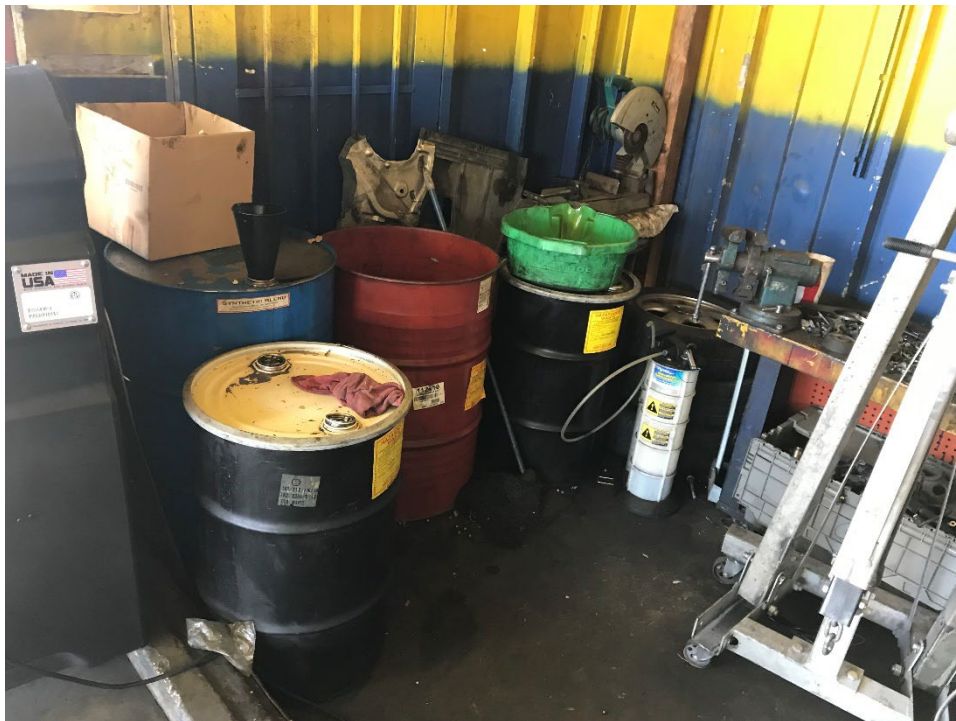
**Photograph 12.** Hazardous waste storage area in the southeastern portion of the auto body shop of the Subject Property building.

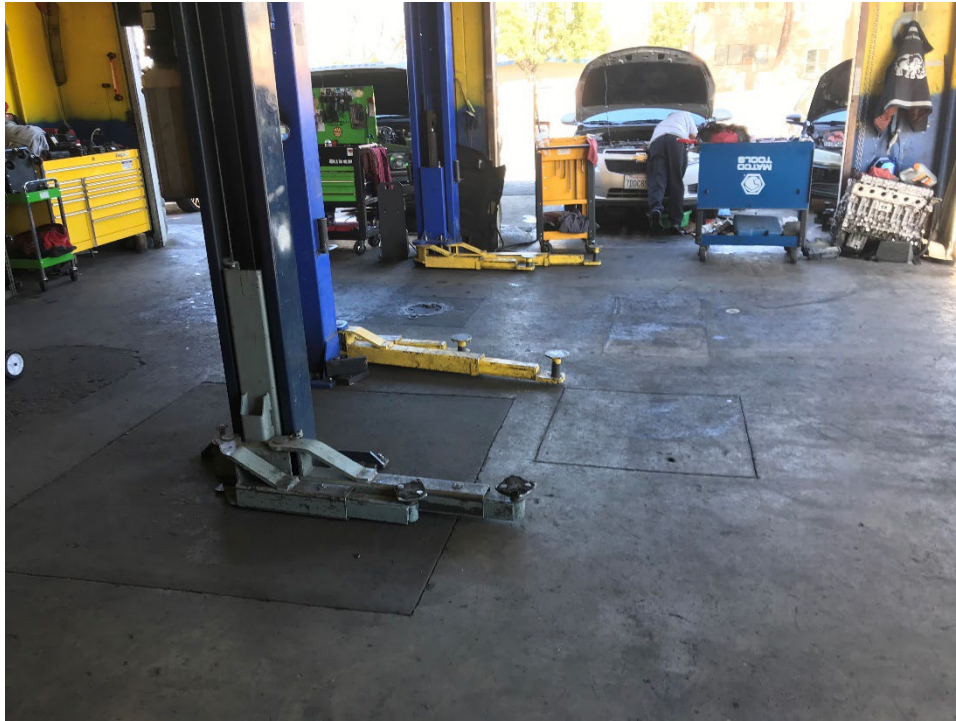
**Photograph 13.** Aboveground hydraulic lifts in the auto repair shop of the Subject Property building.

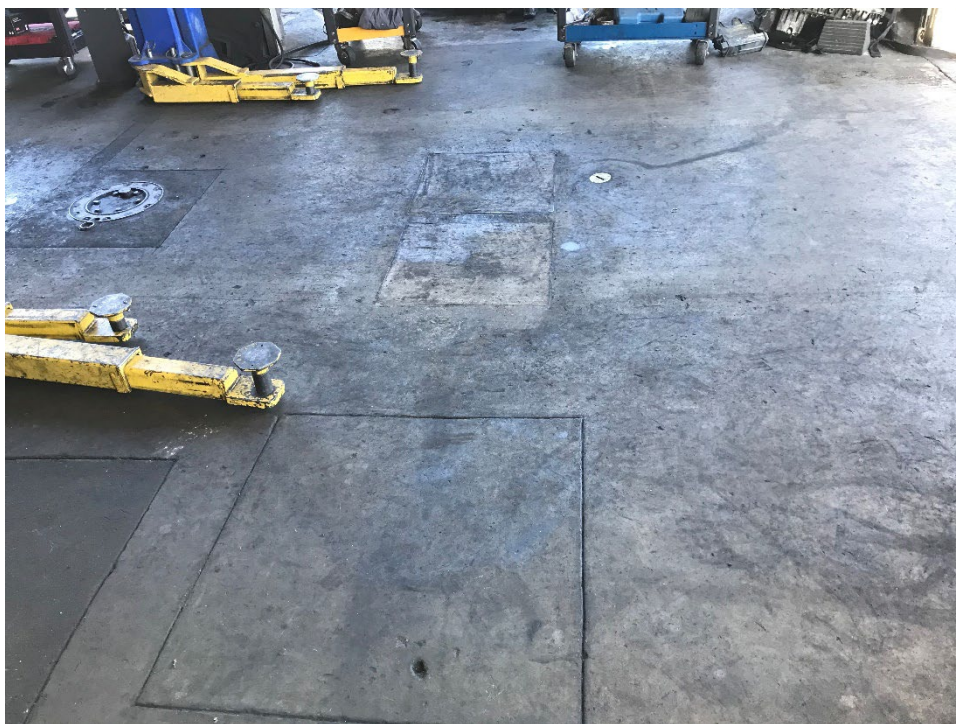
**Photograph 14.** Patched area inside the auto body shop; possible former clarifier.

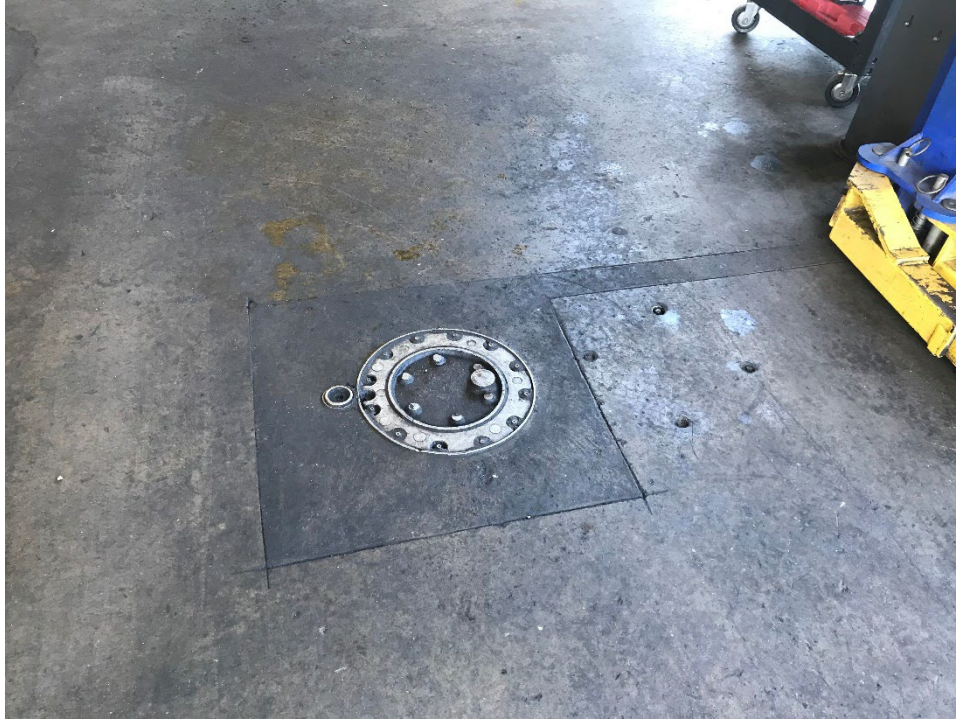
**Photograph 15.** Former in-ground piston lift in the auto repair shop of the Subject Property building.

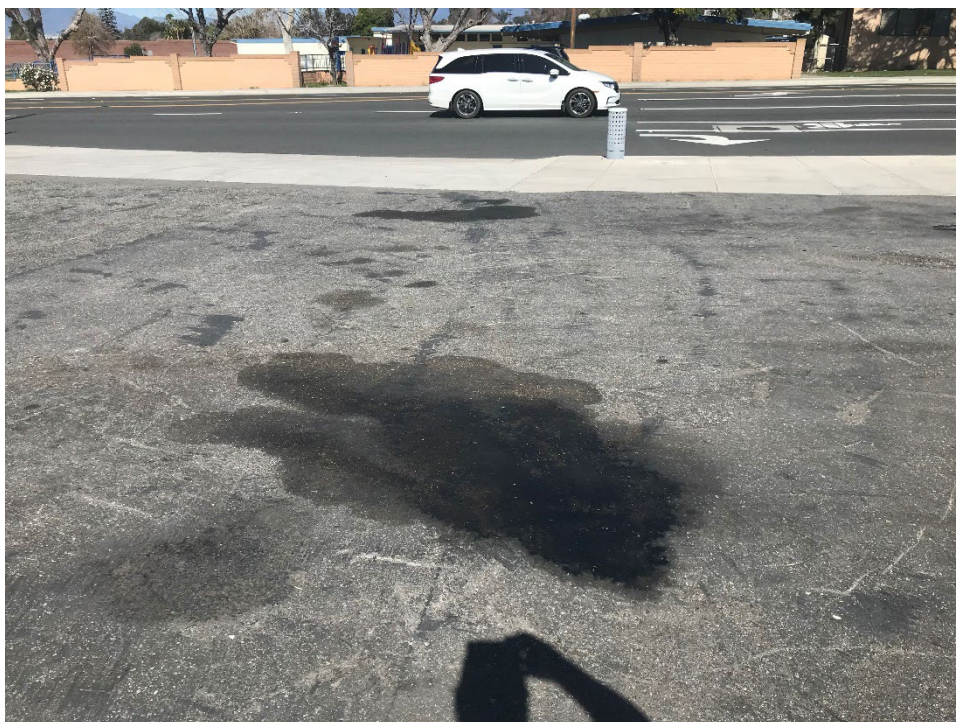
**Photograph 20.** Staining in the parking area of the Subject Property.

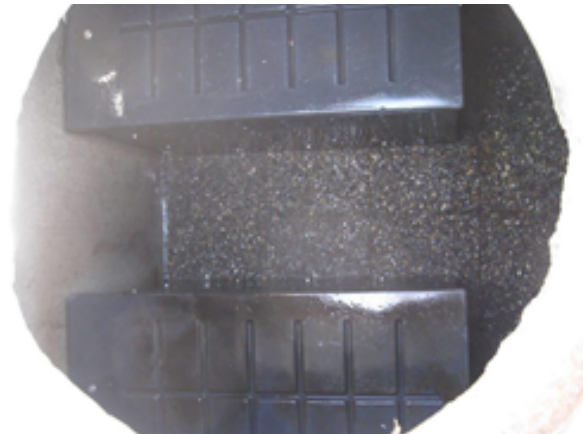
1. Remove access cover over pre-treatment chamber and position vacuum truck accordingly.
2. With a pressure washer, spray down pollutants accumulated on walls and pre-filter cartridges.
3. Vacuum out pre-treatment chamber and remove all accumulated pollutants including trash, debris, and sediments. Be sure to vacuum the floor until the pervious pavers are visible and clean.
4. If pre-filter cartridges require media replacement, continue to step 5. If not, replace access cover and move to step 11.

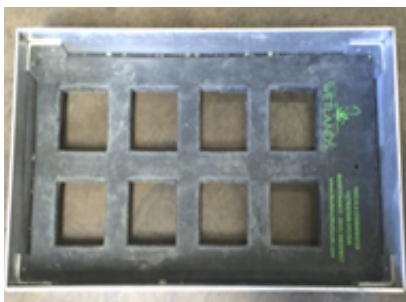
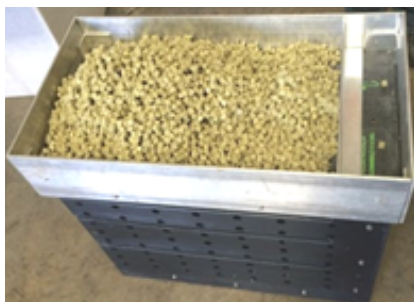
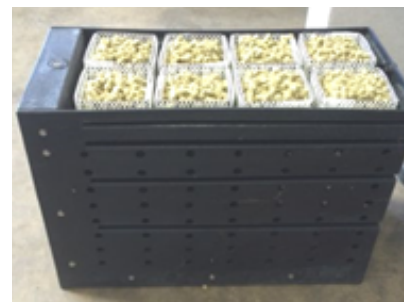
8. Once filter media has been sucked out, use a pressure washer to spray down the inside of the cartridge and it's media cages. Remove cleaned media cages and place to the side. Once removed, the vacuum hose can be inserted into the cartridge to vacuum out any remaining material near the bottom of the cartridge.
9. Reinstall media cages and fill with new media from the manufacturer or outside supplier. Manufacturer will provide specification of media and sources to purchase. Utilize the manufacture-provided refilling tray and place on top of the cartridge. Fill the tray with new bulk media and shake down into place. Using your hands, lightly compact the media into each filter cage. Once the cages are full, remove the refilling tray and replace the cartridge top, ensuring bolts are properly tightened.

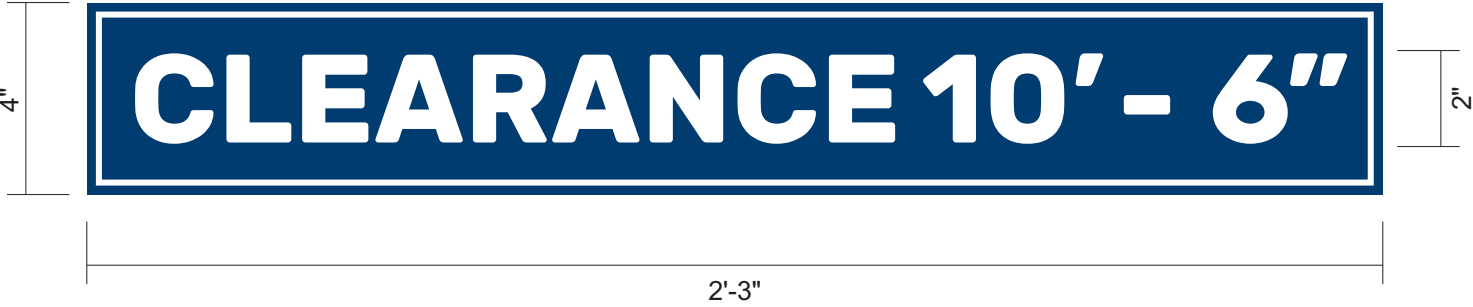
CLEARANCE SIGN  
SCALE: 3"=1'-0"

3MM ACM SIGN PANEL PAINTED DB CUSTOM DARK BLUE.  
WHITE REFLECTIVE VINYL COPY & BORDER (NUMBERS SHIPPED LOOSE & FIELD APPLIED).  
MOUNT DIRECTLY TO ALUMINUM AWNING DRIVE-THRU ENTRANCE SIDE  
WITH EXTERIOR GRADE 3M VHB TAPE.
